Aviation Safety

Letter

Issue 4/2001

Déjà Vu—Frost Causes Loss of Control

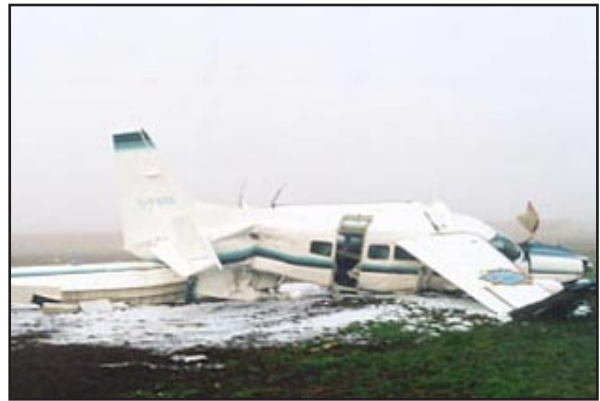
When the aircraft contacted the ground, it was in a left bank, with a near level pitch attitude. The floats absorbed much of the impact force and separated from the aircraft during the impact sequence. Damage to the propeller assembly was consistent with the engine producing power at impact.

The aircraft had been parked overnight on the ramp at Abbotsford and had accumulated a layer of frost, which the pilot noted. He used cold tap water to remove frost from the windshield in order to see out

of the aircraft. The pilot also checked the top of the wings during his pre-flight check and noted a layer of frost, which he indicated to be about $\frac{3}{16}$ in. thick, but he assessed that it was insignificant. He believed that the sun would melt all the frost and that de-icing the wings would not be necessary. The sun rose at 0810 and was about eight degrees above the horizon by the time the aircraft took off. Ambient temperatures at 0900 and 0920 were recorded as -2.8°C and -0.5°C , respectively. The extent to which the early morning sun would have melted frost from the wing surfaces is negligible. The wings were not examined to confirm that the frost had melted before takeoff.

Witnesses who were experienced in aircraft icing/de-icing operations reported that the Caravan was covered in a pronounced layer of frost, about $\frac{1}{4}$ in. thick. Adjacent aircraft were significantly covered in frost and ice, resulting in scheduled flights being postponed; those aircraft remained frost-covered until late that morning.

Analysis—The TSB concluded that the aircraft was contaminated with frost during the takeoff, which would have increased drag and reduced the ability of the wings to produce lift. The aircraft was also overloaded, which adversely affected aircraft performance. The decreased performance of the aircraft during the takeoff and climb is attributable to the combined effects of aircraft overloading and wing and flight control surface contamination. As well, increased weight and surface contamination both increase the stall speed of an aircraft. When the flaps were retracted, further reducing lift, the aircraft experienced an aerodynamic stall and loss of control from which the pilot was unable to recover. Finally, because the wings were contaminated, the classic stall indicators of aircraft buffet and audible stall warning were likely absent, at least initially. \triangle

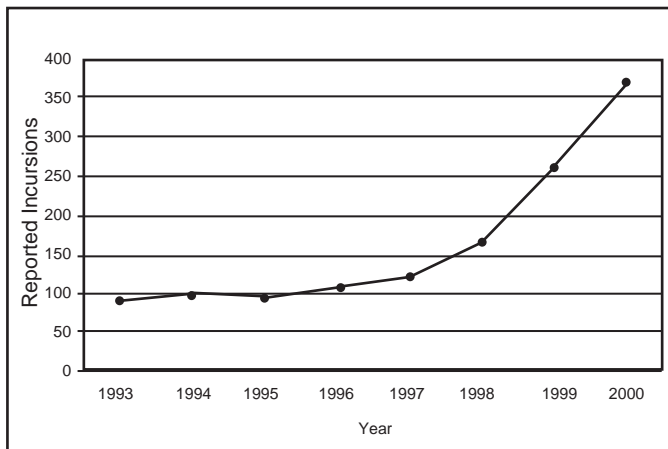
Figure 1

The Transport Canada study team found that, from 1996 to 1999, the number of runway incursions reported at Canadian aerodromes increased by 145%. While not included in the report, the figures for 2000 kept rising: 368 incursions were recorded for the year, representing a 40% increase over 1999.

These figures clearly indicate that the number of runway incursions at Canadian aerodromes has increased sharply in recent years and is continuing to do so.

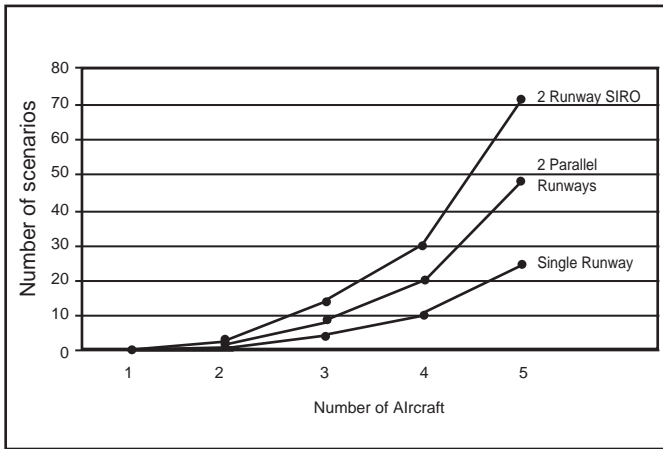
Figure 2

By virtue of their complexity, these procedures offer more ways in which a conflict can develop, as illustrated in Figure 2. Though not shown here, intersection departures and/or a three-runway SIRO will further increase the complexity and create yet more opportunities for a runway incursion.

Two conclusions can be drawn from this analysis. First, as traffic volume increases, runway incursion *potential* increases more rapidly when capacity-enhancing procedures are in effect than when they are not. Second, if traffic remains the same, the *potential* for runway incursions increases when capacity-enhancing procedures are put into operation.
